UPPER TUMBLING RUN DAM

PHASE I INSPECTION REPORT NATIONAL DAM INSPECTION PROGRAM

AUGUST 1978

UPPER TUMBLING RUN DAM
SCHUYLKILL COUNTY, PENNSYLVANIA
NATIONAL I.D. NO. PA 00689

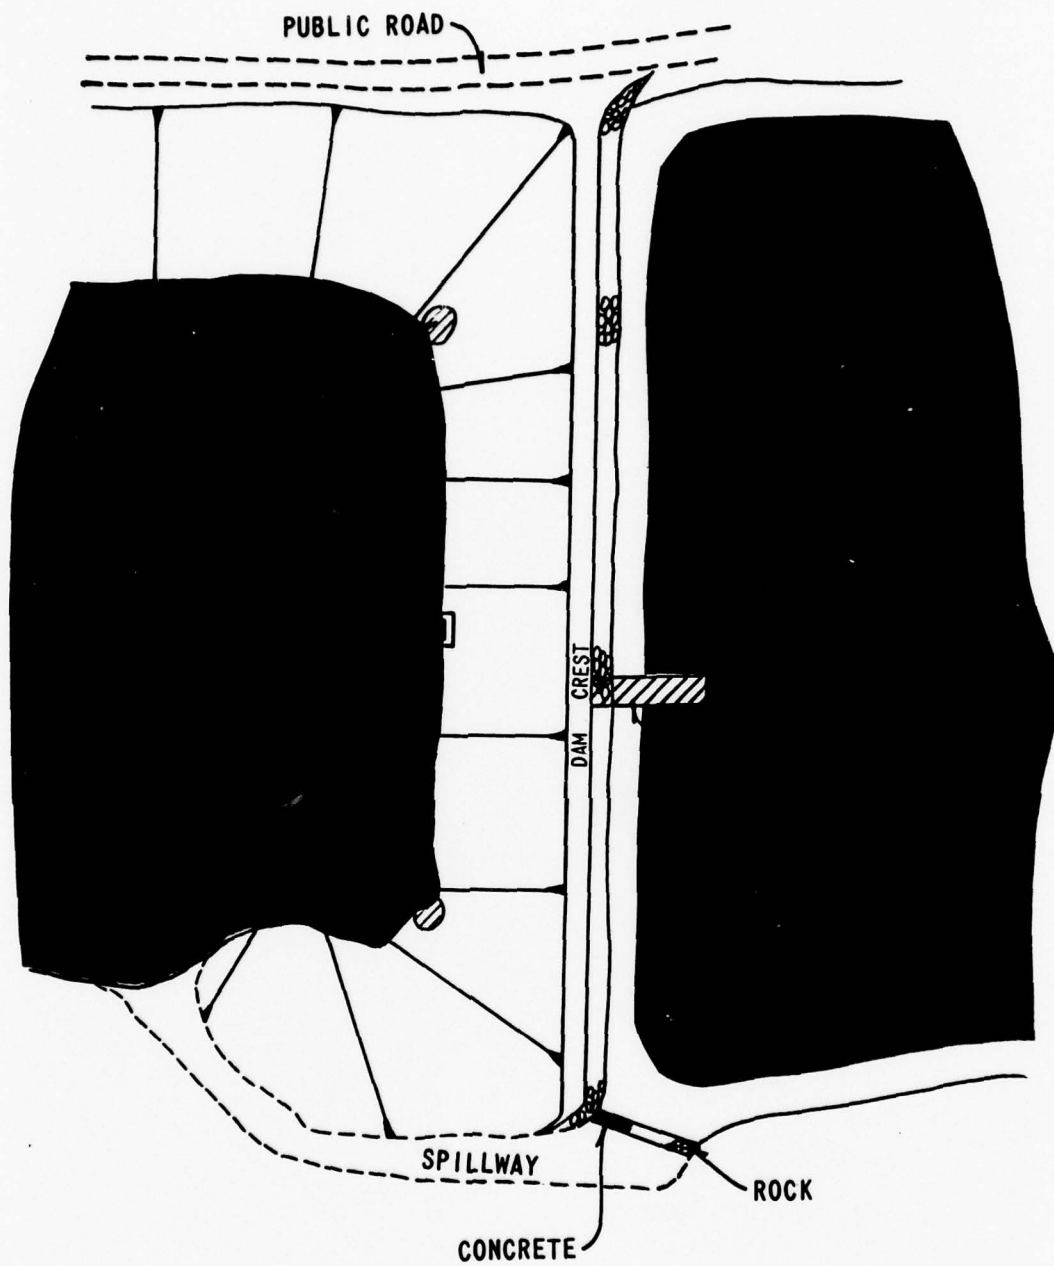
SEEPAGE LOCATION PLAN
UPPER TUMBLING RUN DAM

ANY NOTICEABLE SEEPAGE	Yes. Seepage was observed along the left downstream abutment and it was clear. Seepage was also noted at the toe of the right abutment but it could not be traced due to debris and dense vegetation. The Owner's representative stated that beavers deposited this debris.	
------------------------	---	--

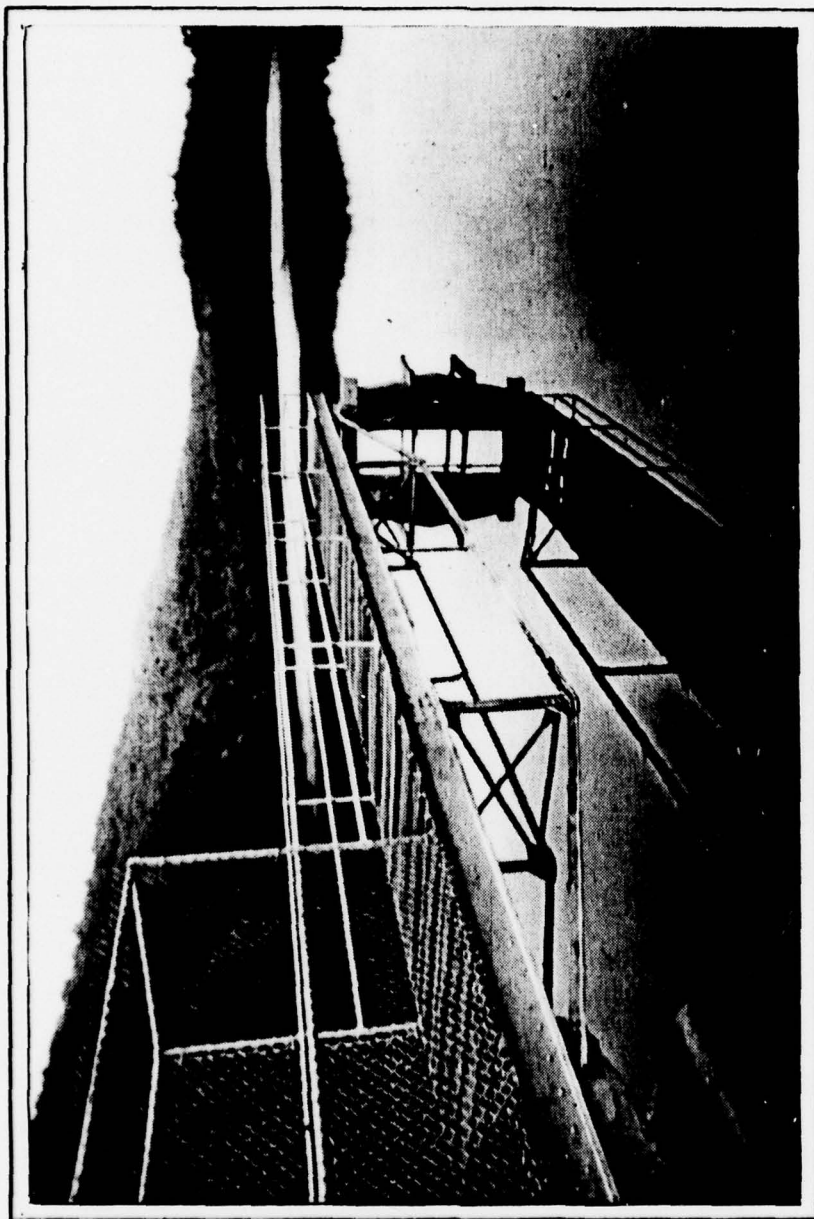
PHOTOGRAPH NO. 1

INTAKE TOWER AND BRIDGE.

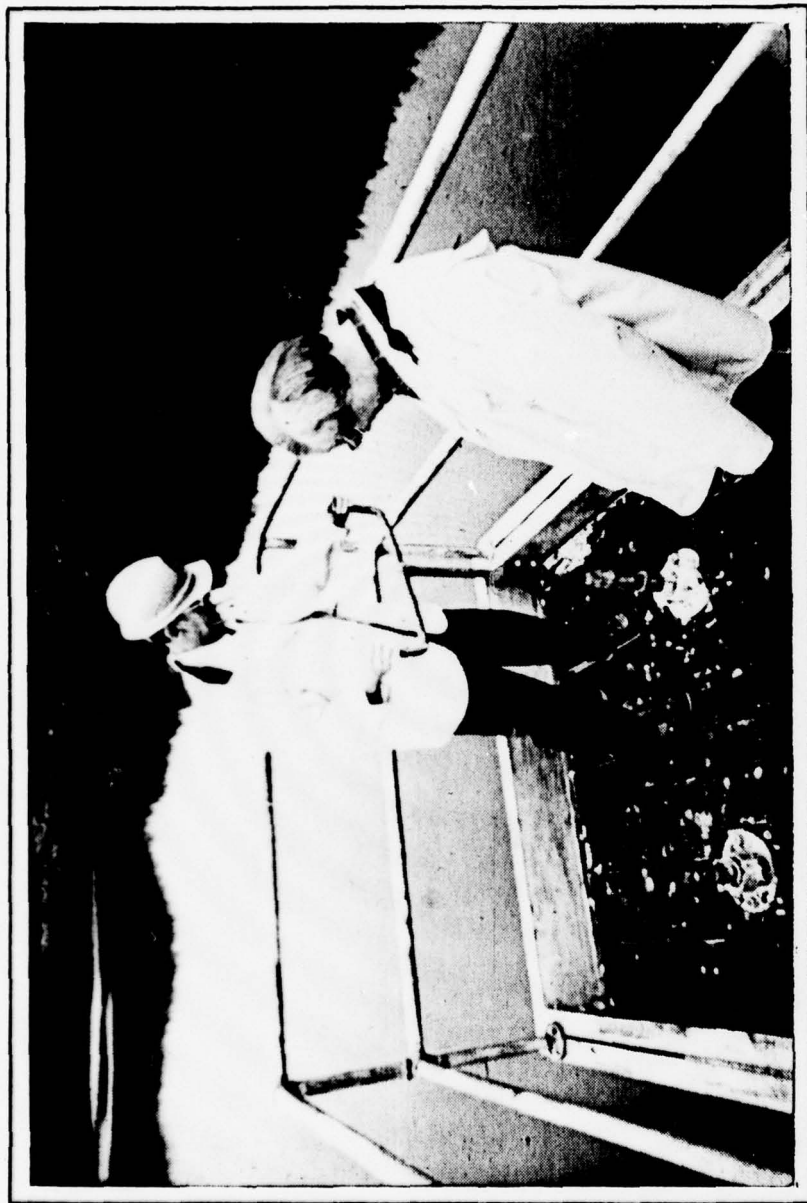
PHOTOGRAPH NO. 2

2. Outlet Works. The outlet works were submerged and could not be inspected. The valves for the two 10-inch I.D. pipes were exercised. However, a slight swirling of the reservoir water surface above and immediately downstream of the outlet structure was observed before and after exercising the valves, indicating leakage. The access bridge supports at the crest were cracked, but were not indicative of an unstable condition.

INTAKE TOWER CONTROL VALVES.

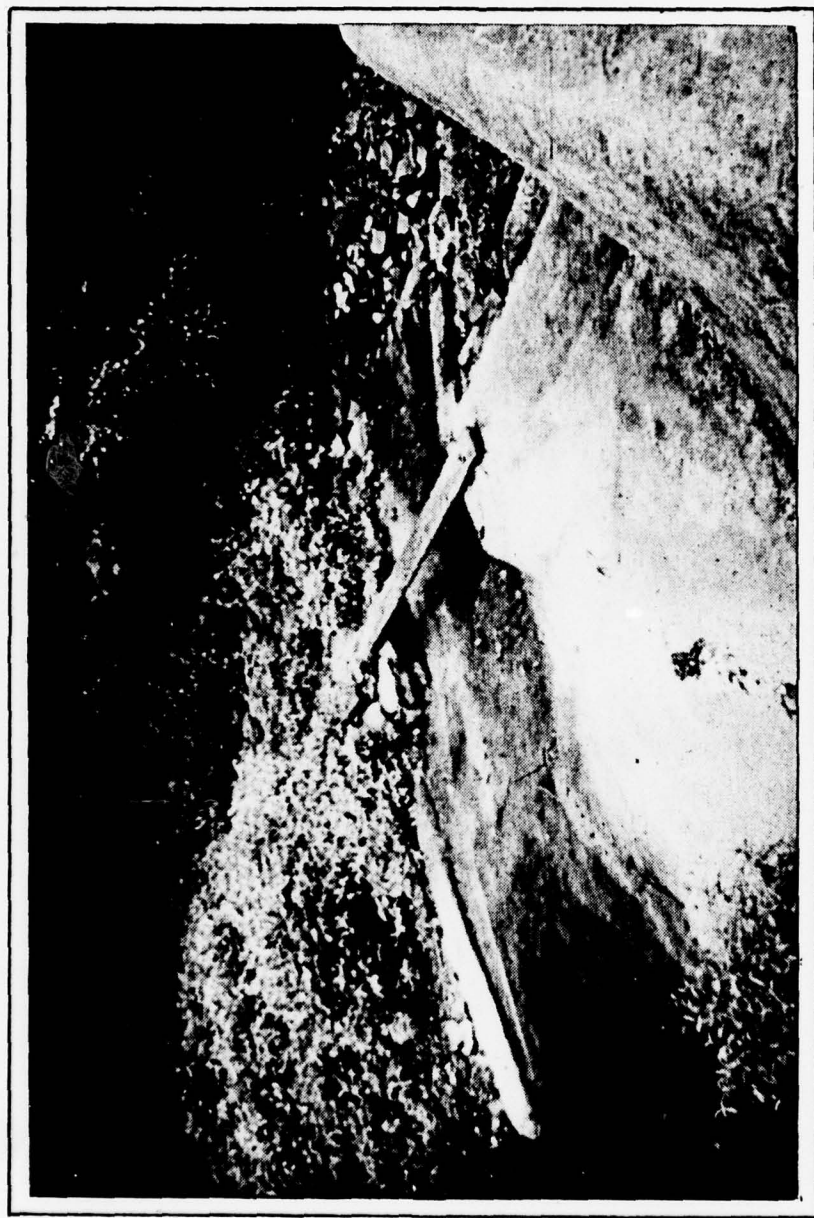
PHOTOGRAPH NO. 4

The crest was measured during the visual inspection and found to be 570 feet long and 12 feet wide. The spillway is 52 feet wide with a notched concrete broad crested weir. The weir notch is approximately 6 feet wide and 1.4 feet deep. See Photograph 4.

1. Spillway. The spillway was excavated into the rock at the left abutment, and measured to be 52 feet wide at the weir section. The right side of the spillway channel has a mortared stone wall which extends downstream to the point at which the channel is directed into the Lower Tumbling Run Dam reservoir. The left side of the channel has been excavated into rock. Erosion was noted near the change in direction of the channel. The spillway bottom is a very irregular rock surface with some rock spalling noted. Woody vegetation was observed growing in the spillway. See Photographs 4 and 5.

VISUAL EXAMINATION OF	OBSERVATIONS	REMARKS OR RECOMMENDATIONS
CONCRETE WEIR	<i>The concrete weir is in poor condition but intact and should function well during normal rainfall. Parts of the channel are overgrown with woody vegetation which should be removed. The concrete is spalled and deteriorated. It should be reconstructed.</i>	
APPROACH CHANNEL	<i>Natural channel is cut through natural rock and is in good condition.</i>	
DISCHARGE CHANNEL	<i>Water over the weir section discharges into the natural rock channel. The channel is rough, contains woody vegetation, and is narrow.</i>	
BRIDGE AND PIERS	<i>None</i>

VIEW OF EMERGENCY SPILLWAY.

The spillway is in fair condition with stable side channels. The rock surface is very irregular and some spalling was observed. Woody vegetation noted within the spillway should be removed.

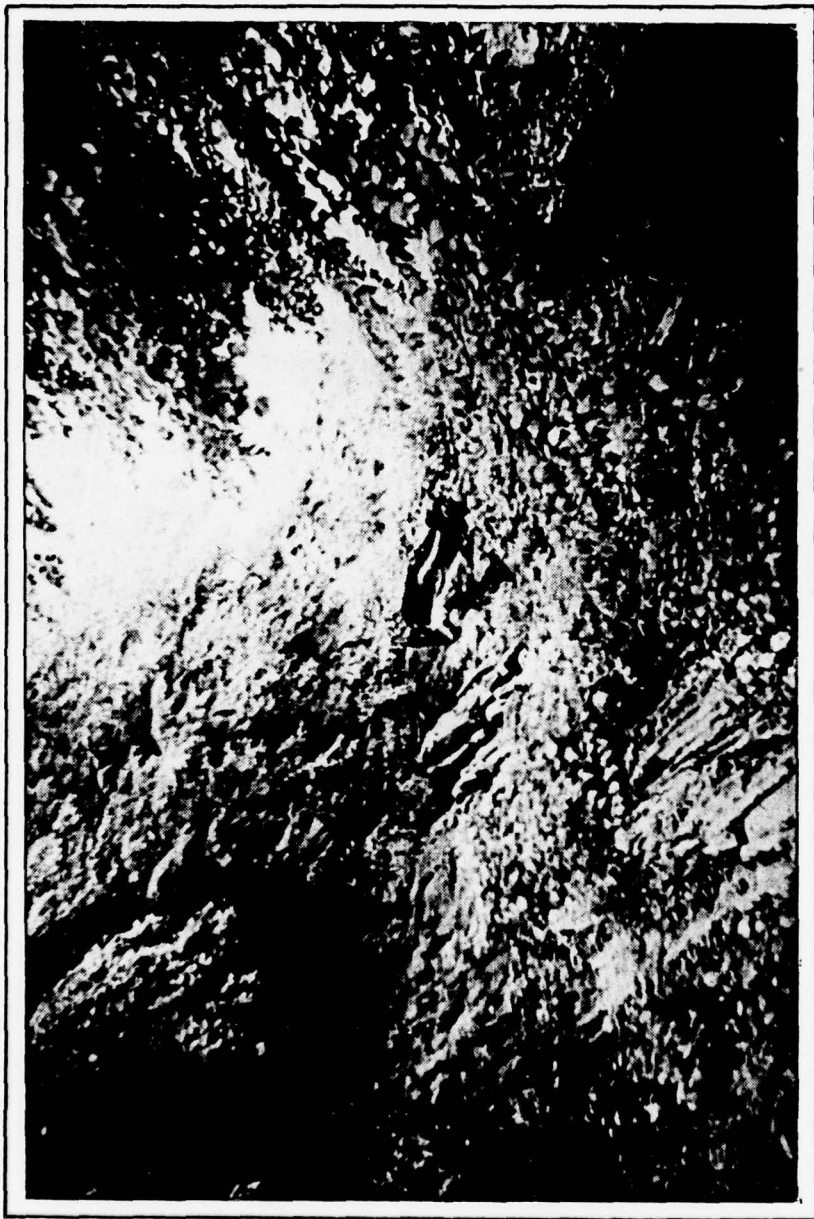
PHOTOGRAPH NO. 5

VIEW OF EMERGENCY SPILLWAY
DISCHARGE CHANNEL.

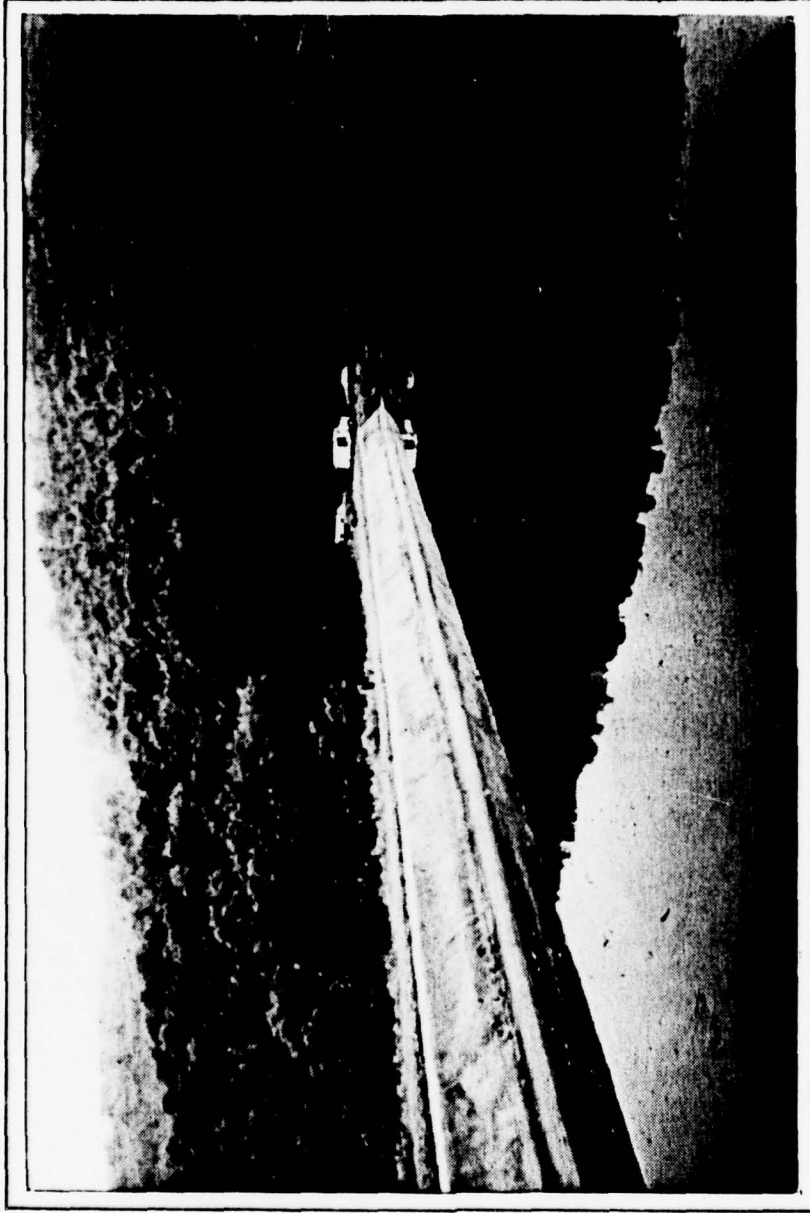
PHOTOGRAPH NO. 6

None observed. Upstream riprap facing was sprayed with gunitite and observed to be in good condition. Since the water level was above the base of the riprap level the condition of the slope below the riprap could not be observed.

OVERVIEW OF UPSTREAM SLOPE.
RIPRAP WAS COVERED WITH
GUNITE GROUT.

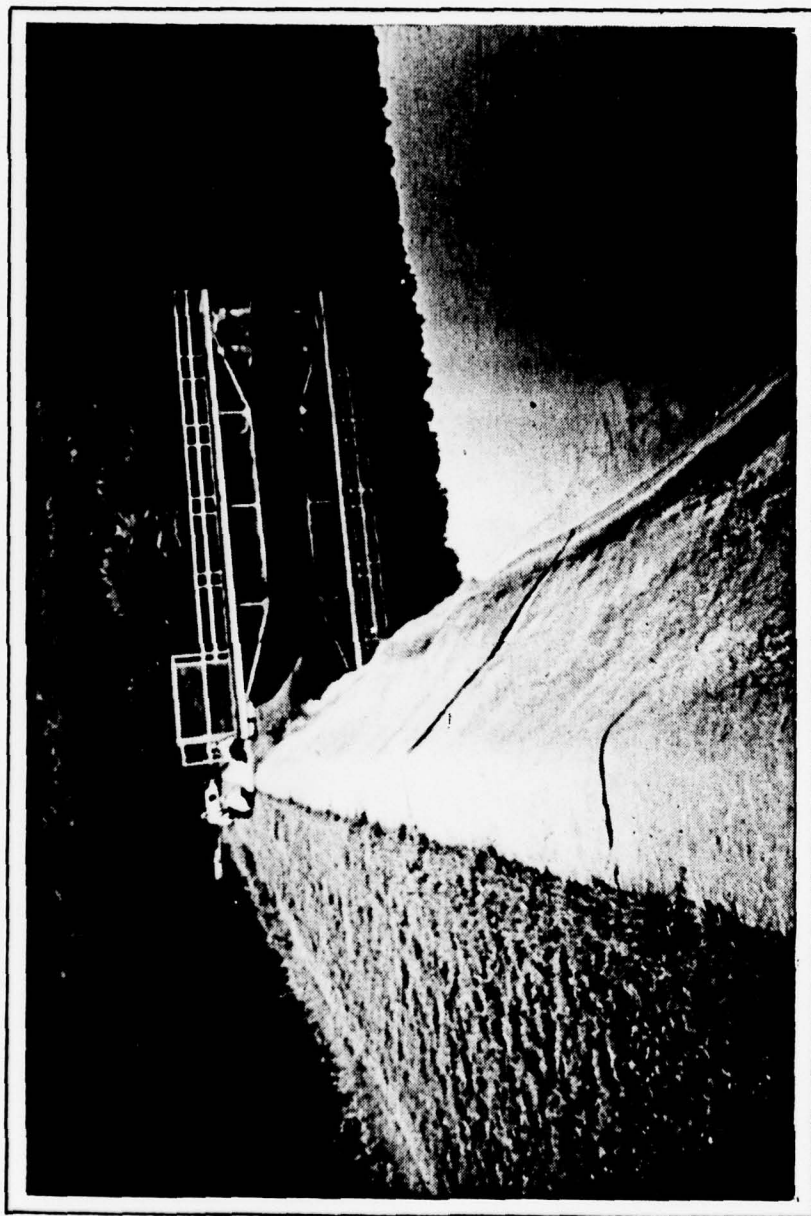
PHOTOGRAPH NO. 7

OVERVIEW OF GROUTED RIPRAP
LOOKING TOWARD RIGHT ABUT-
MENT. SURFACE UNDULATES BE-
CAUSE OF ROCK SURFACE.

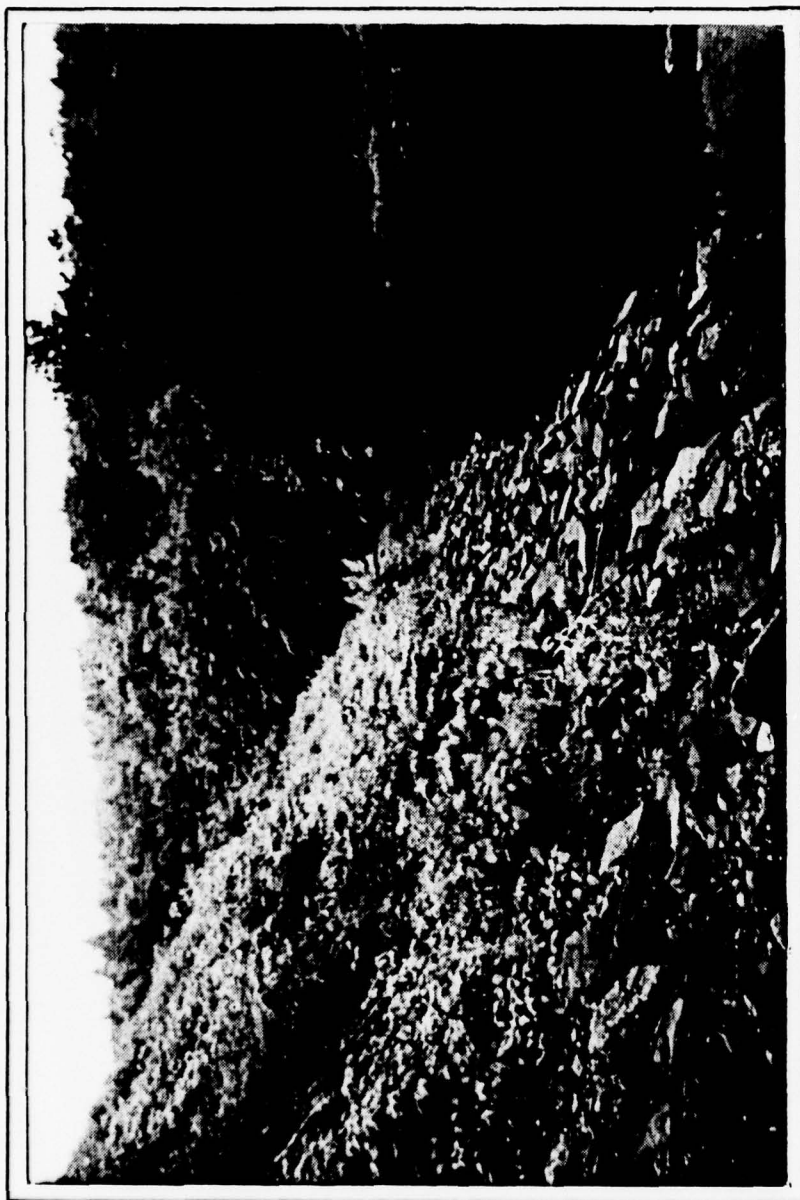
PHOTOGRAPH NO. 9

OVERVIEW OF RIPRAP AT DOWNSTREAM
TOE. THE WATER IS THE UPPER END
OF LOWER TUMBLING RUN RESERVOIR.

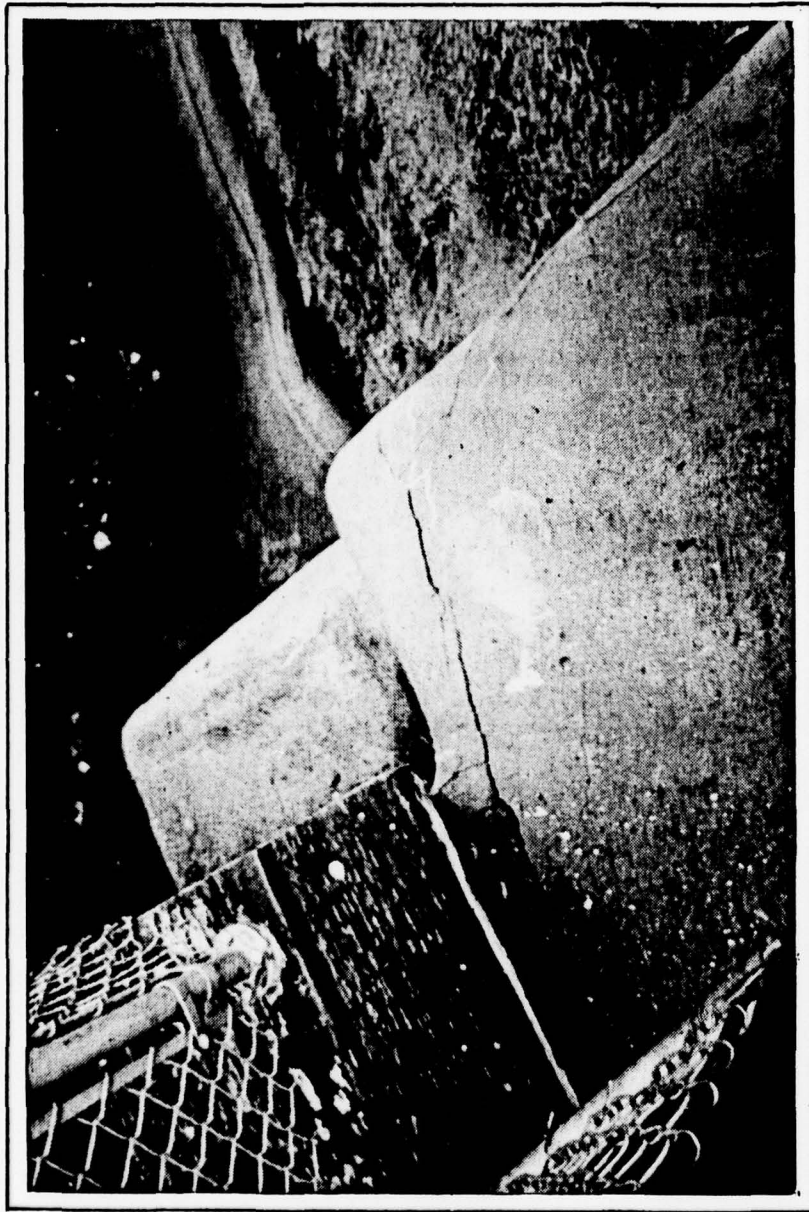
PHOTOGRAPH NO. 11

The support at the dam crest for the access bridge was noted to be cracked, but judged to be currently stable. A detailed study is in order to determine the future service life of the existing outlet works, and to determine if and when replacement is warranted.

CRACKED ABUTMENT OF SUPPORT FOR
BRIDGE FROM EMBANKMENT TO THE
CONTROL TOWER.

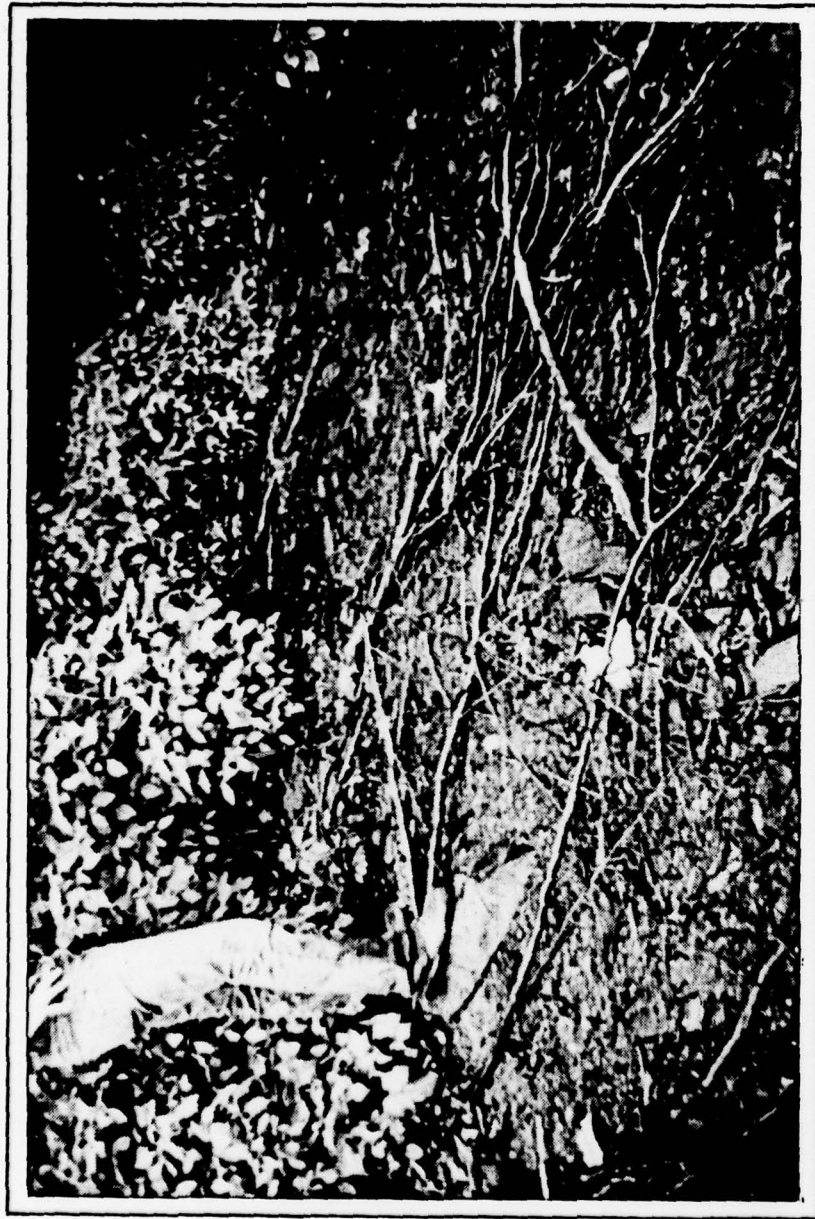
PHOTOGRAPH NO. 12

SEEP FROM LEFT ABUTMENT INTO
LOWER TUMBLING RUN RESERVOIR.

1. The underbrush along both abutments should be cleared to facilitate a thorough visual inspection of the seepage sources.
2. Seepage measuring devices should be installed to monitor seepage rates and changes in turbidity.
3. Formal operations and maintenance and warning procedures should be developed, implemented and incorporated into the water treatment facilities operation. The warning procedure should include a method of warning downstream residents that high flows are to be expected. Evacuation procedures should also be developed.
4. The Owner should also develop an inspection checklist as an amendment to the maintenance procedure to insure that all critical items are inspected and maintained on a periodic basis.

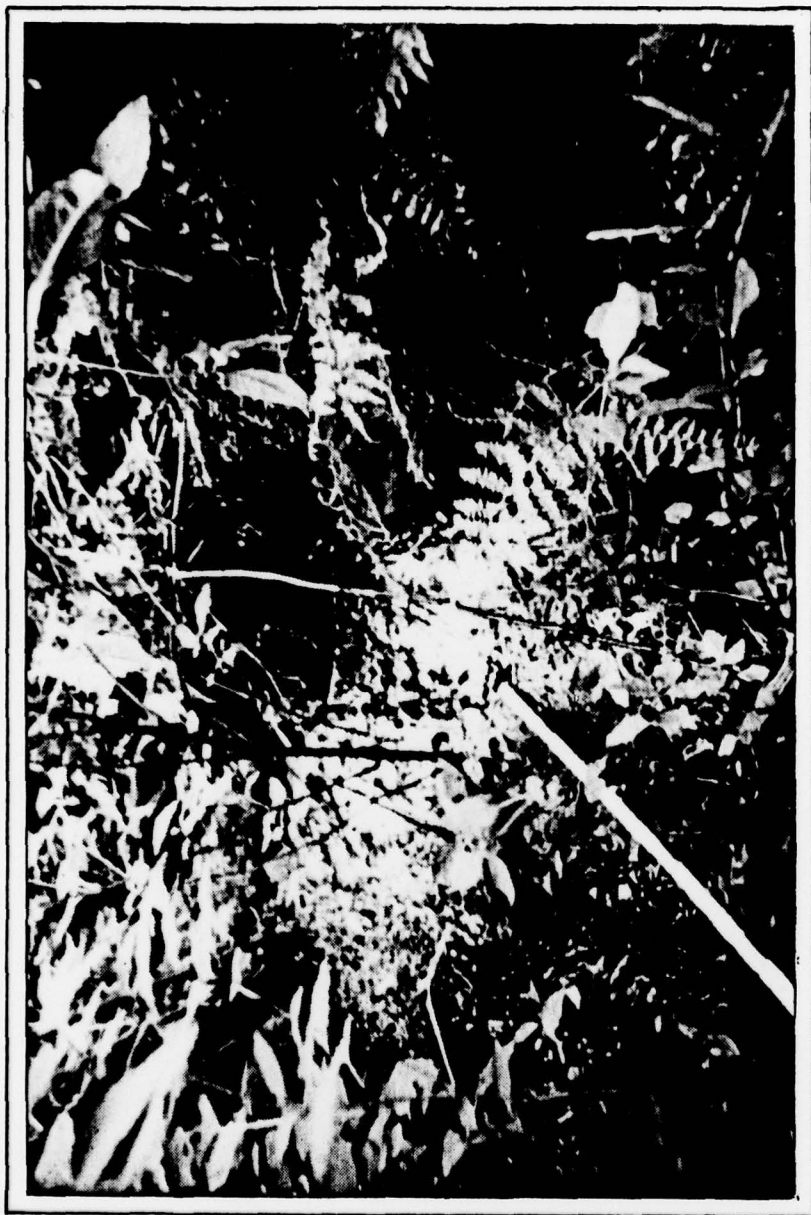
PHOTOGRAPH NO. 13

CLOSE-UP OF SEEPAGE FROM LEFT
ABUTMENT. SEE PHOTOGRAPH NO. 12
FOR OVERVIEW.

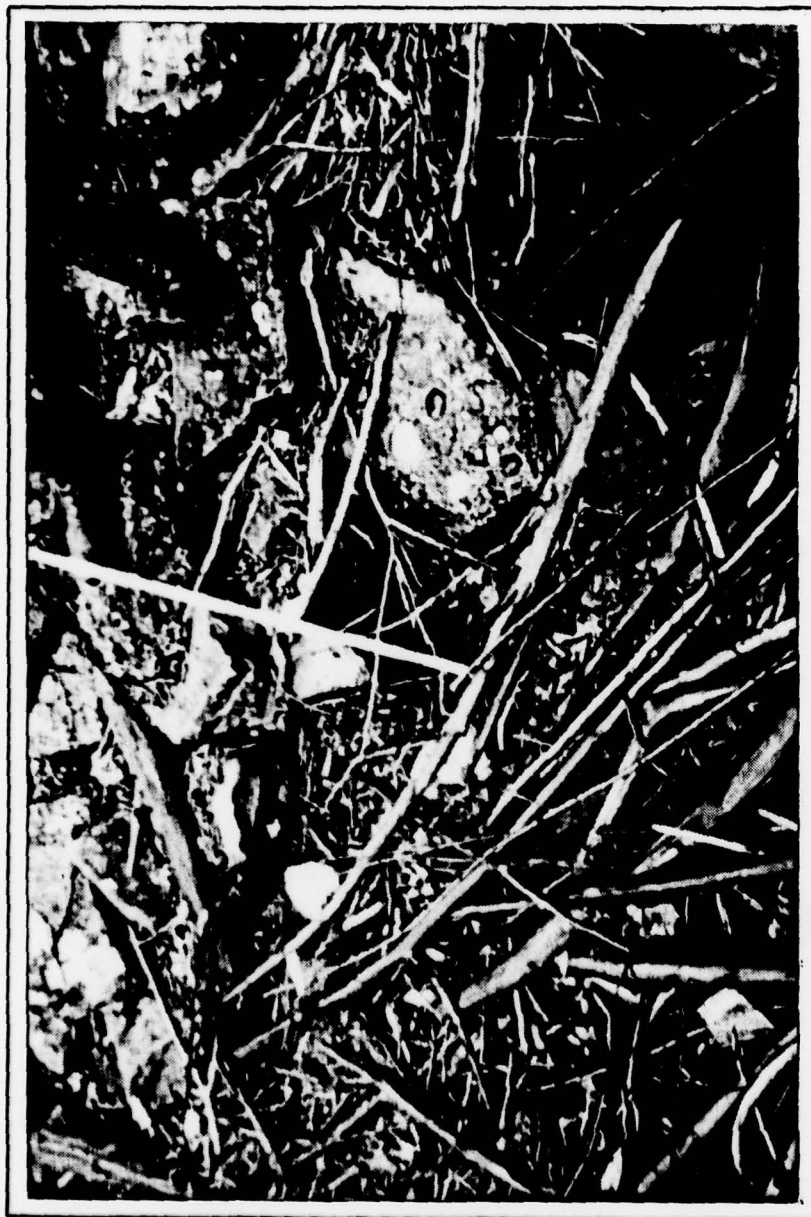
PHOTOGRAPH NO. 14

SEEPAGE FROM RIGHT ABUTMENT WITH
FLOW DISCHARGING INTO LOWER
TUMBLING RUN RESERVOIR.

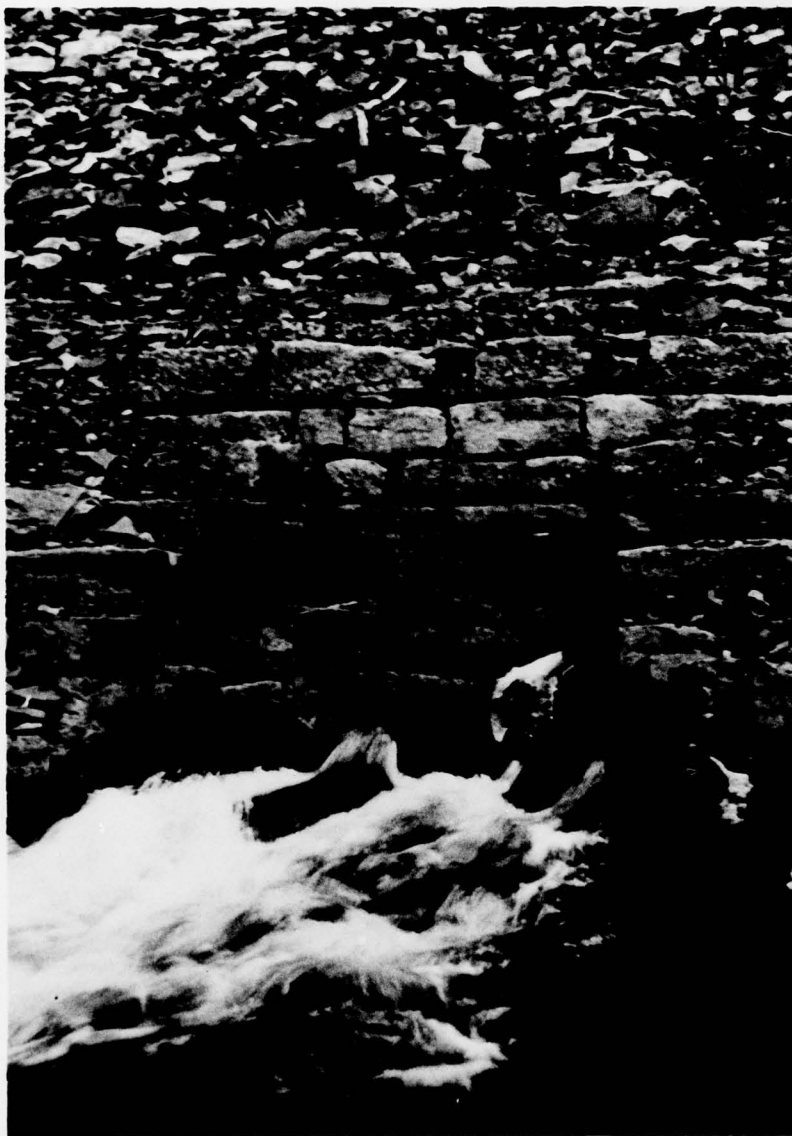
PHOTOGRAPH NO. 16

The intake structure is a vertical masonry block wall constructed within the upstream slope, as shown in Photograph No. 15. The discharge structure is also stone masonry with the walls extending approximately 6 feet above the pipes. No changes or modifications to the outlet works have been reported. See Photograph No. 16.

EXPOSED OUTLET STRUCTURE
PHOTOGRAPHED BY SILVER
CREEK WATER COMPANY, MARCH
25, 1914
